SPOFFORD LAKE DAM

NH 00356

PHASE I INSPECTION REPORT
NATIONAL DAM INSPECTION PROGRAM

NOVEMBER 1978

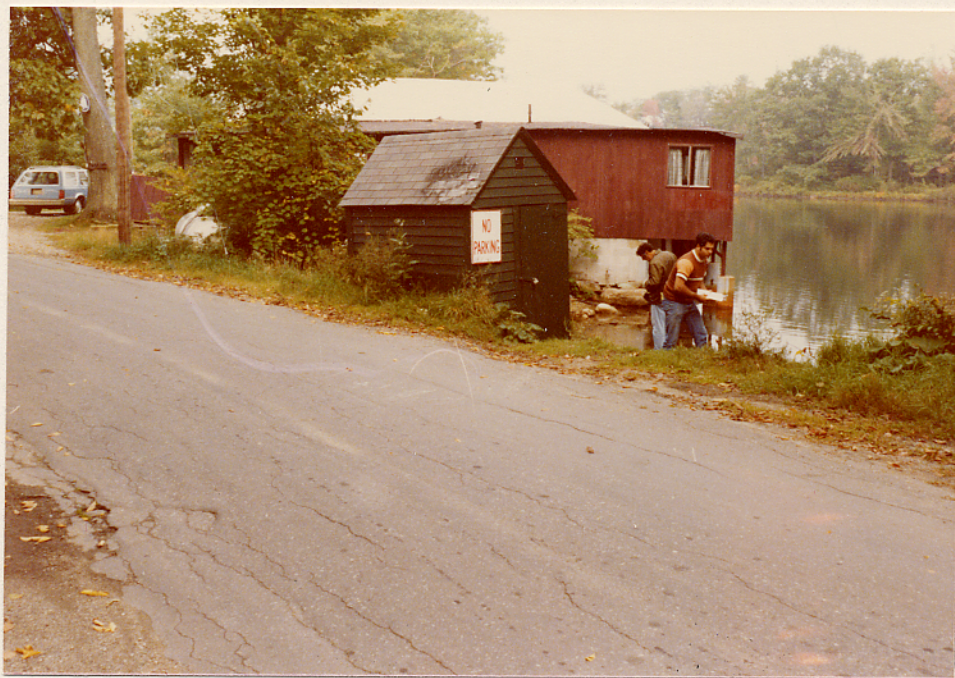
Overview of dam from left abutment showing gate house and approach channel

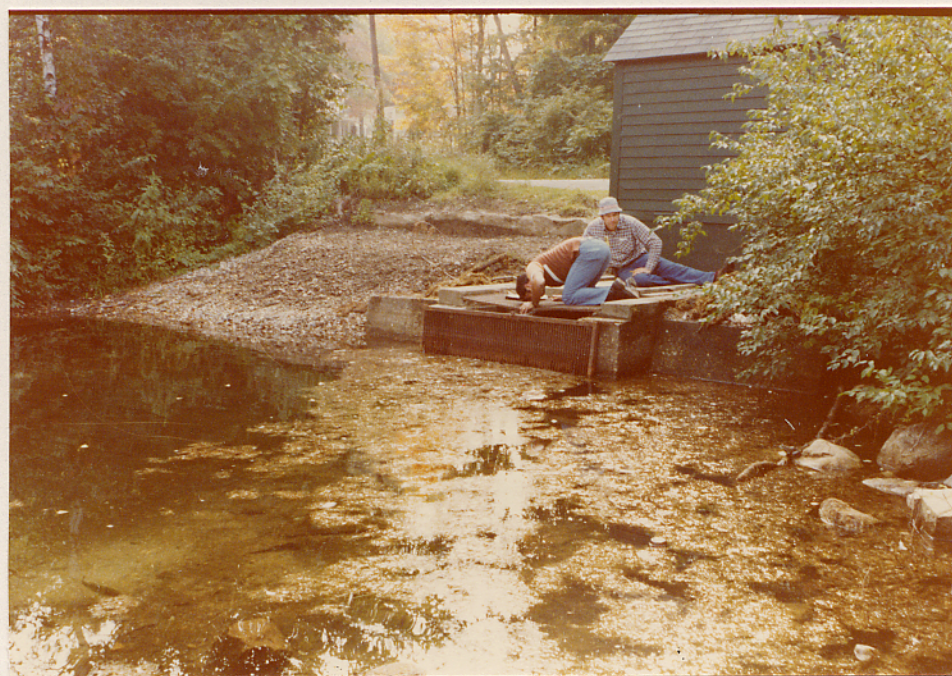
Overview of dam from right side upstream showing inlet area

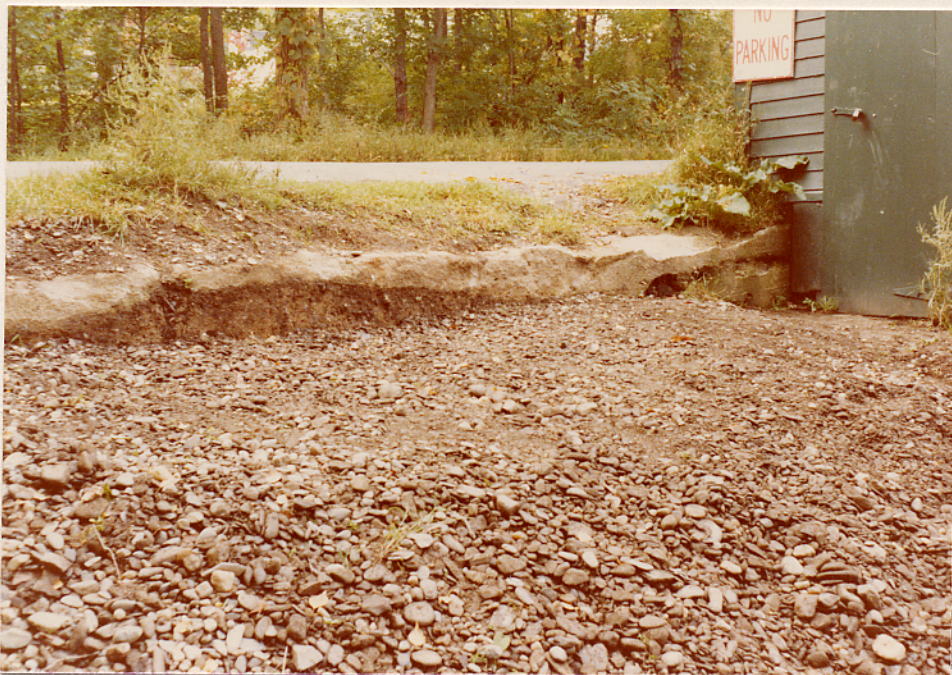
The upstream face of the dam is an 18 inch thick, vertical concrete wall, but gravel has since been dumped in front of the wall on the left side of the dam to provide fire trucks access to the lake for drawing water. Only 12 to 18 inches of concrete remains exposed on the left side, compared to 2 to 3 feet on the right. The top part of the left side of the wall is significantly deteriorated, partly by erosion and partly by trucks driving over it. A few voids up to 12 square inches in area and 2 inches deep were noted on the face. Evidence of erosion and spalling is present to a minor degree at joints, while aggregate has been exposed over 50% of the surface. Random hairline cracking is evident over most of the wall. The right side of the wall is in somewhat better condition, displaying only minor erosion and random hairline cracking. There is no evidence of cracking or sloughing of the fill near the upstream wall.

1. View of upstream concrete wall showing deterioration of concrete

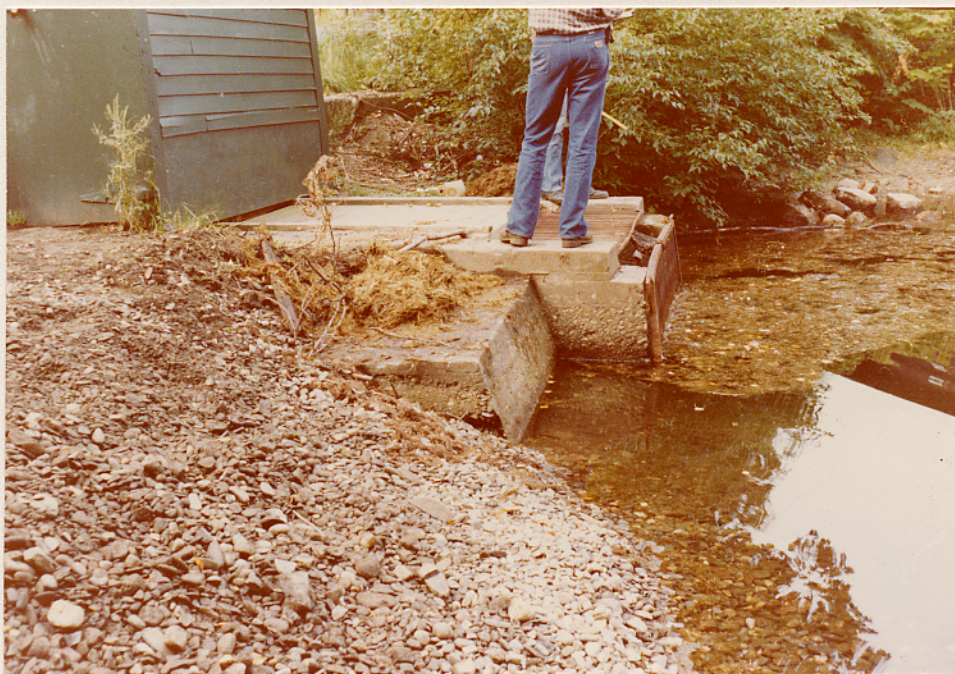
The two inlet walls are in fair condition despite surface erosion exposing aggregate, minor spalling, random hairline cracking and some deterioration at joints. The soil under the walls has been eroded to a depth of at least 6 inches.

The two smaller walls parallel to the front face of the dam display identical deficiencies. Erosion is occurring at the ends of these walls, resulting in 6 to 12 inches of the walls acting as a cantilever.

2. View of inlet area from left side showing erosion of concrete

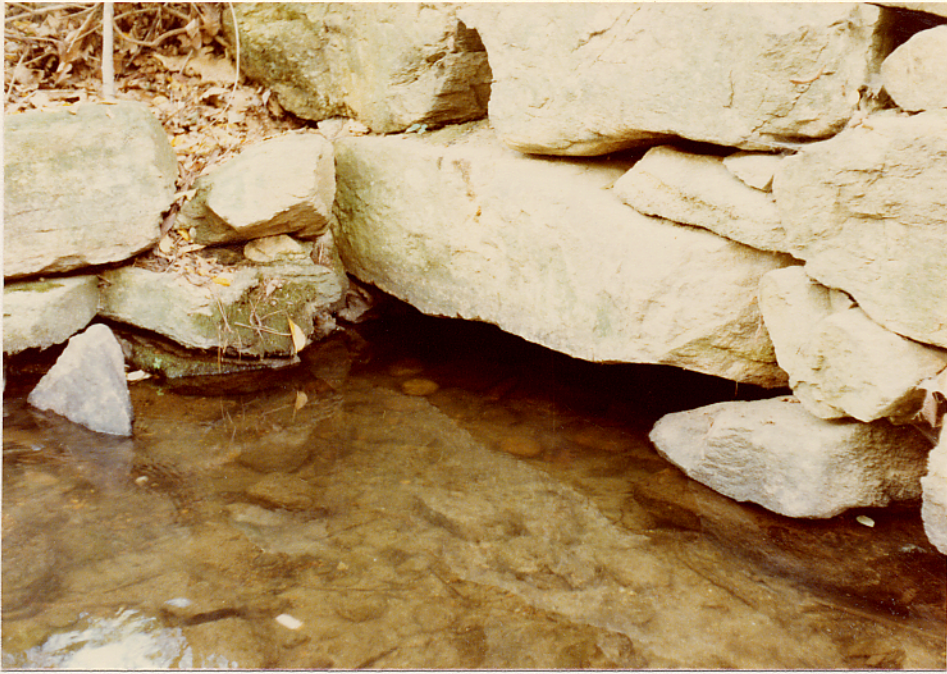
The downstream face of the dam is an open jointed, squared stone masonry structure. The wall is approximately 1.5 to 2 feet thick at the top. Neither displacement nor seepage through the wall was observed. There is no evidence of distress in the fill behind or at the toe of the wall.

3. View of outlet area in downstream squared stone masonry wall

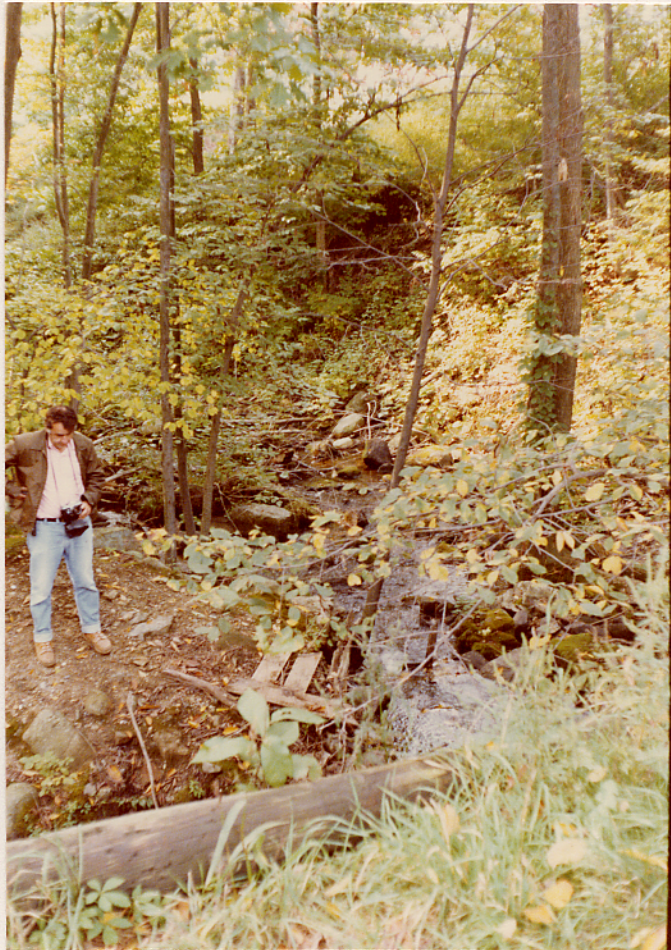
The channel downstream of the dam follows 2 courses, one of which may have once carried water to a mill. The channel is fairly steep and generally well defined, but has heavy vegetation growing in and all around it. A few buildings are constructed directly on the banks and could be affected in the event of dam failure. The channel passes under several local roads, including Route 9A twice. There are no obstructions in the channel which would adversely affect the operation of the dam, particularly in light of the dam's limited discharge capacity.

4. View of downstream channel from road
